Date of visit : 4/12/18 – 6/12/18

Engineers Comments

Visited site to inspect and evaluate the customer's MP125 extruder line.
The machine was last run in 1992.

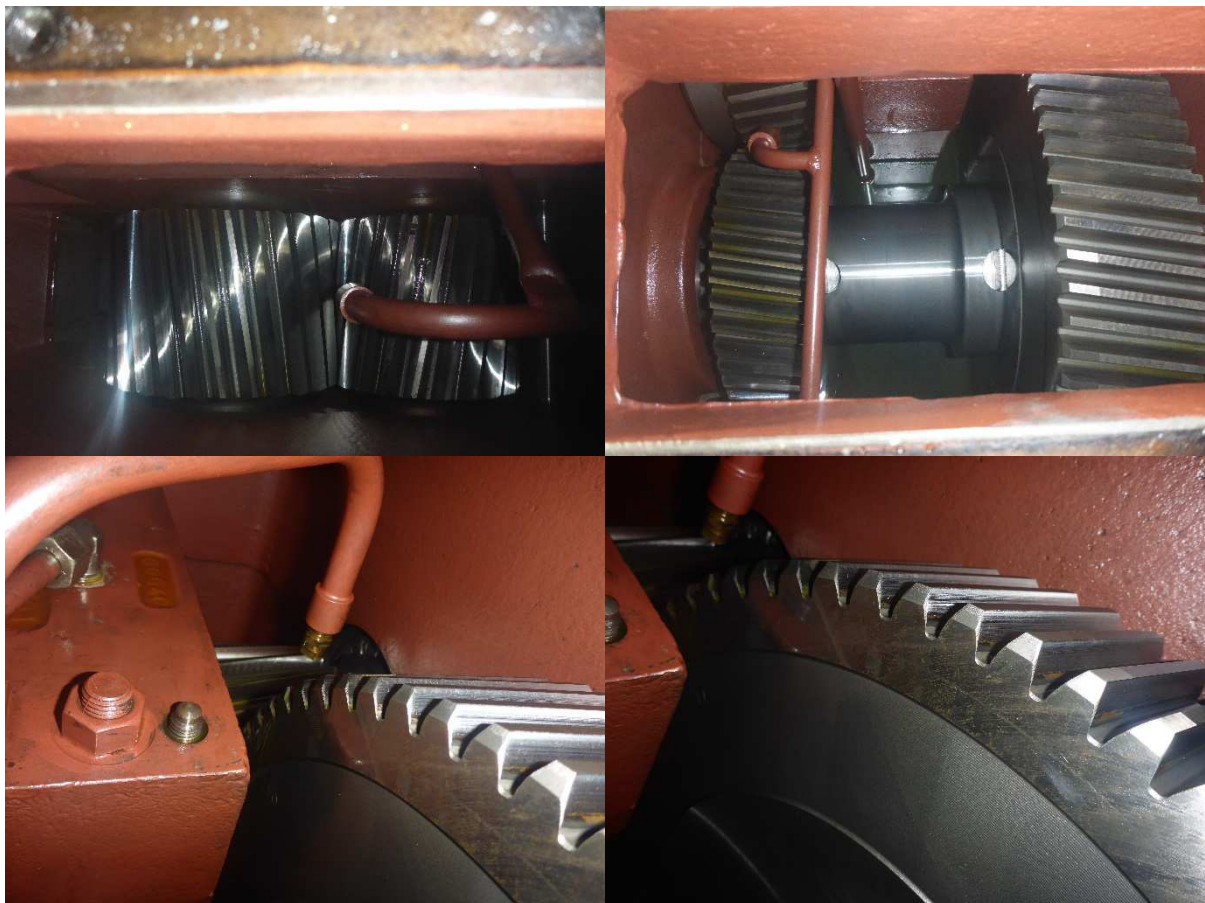
The top inspection covers were removed in order to gain access to the gears, these appear to be in good condition. See photo's below.

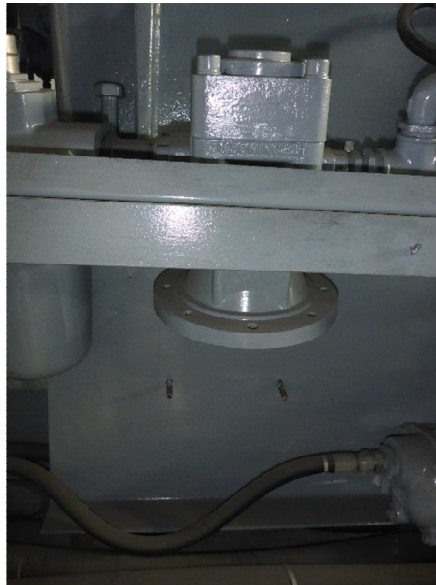
The torque limiter coupling has no identity plate of setting stamp but appears to be in good condition.

The lubrication pump motor is missing and could not be located.

The lubrication pump motor needs to be found/replaced.

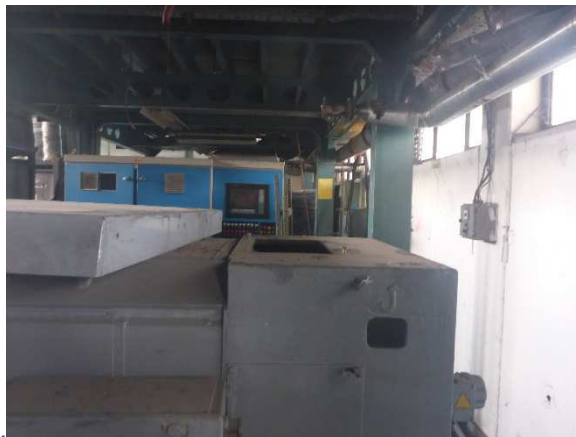
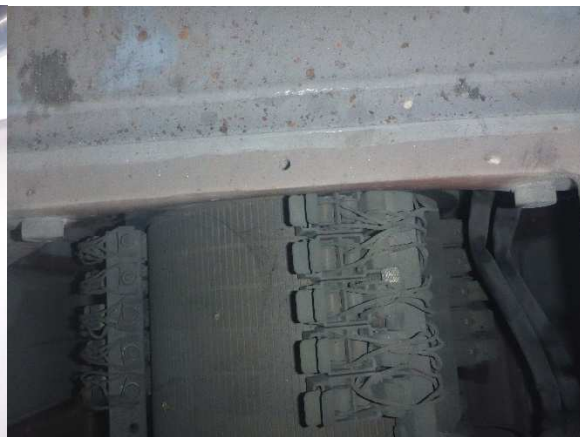
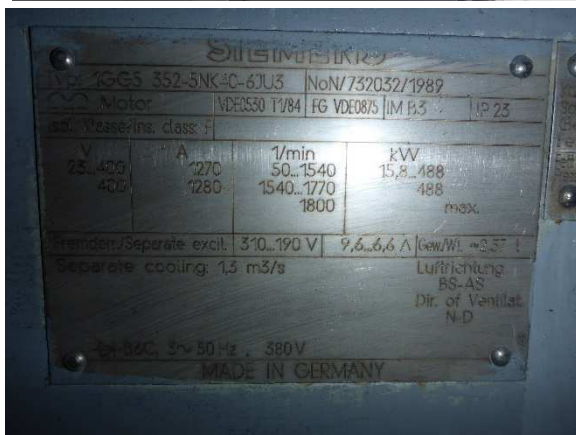
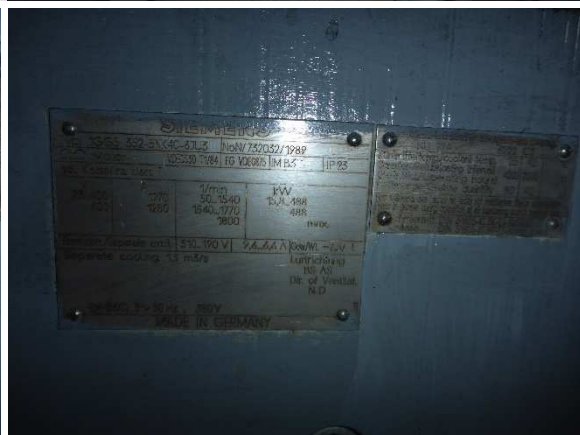
The drive motor blower is missing and could not be located. This has enabled dirt to enter the motor but no damage to commutator is evident.

The blower motor needs to be found/replaced

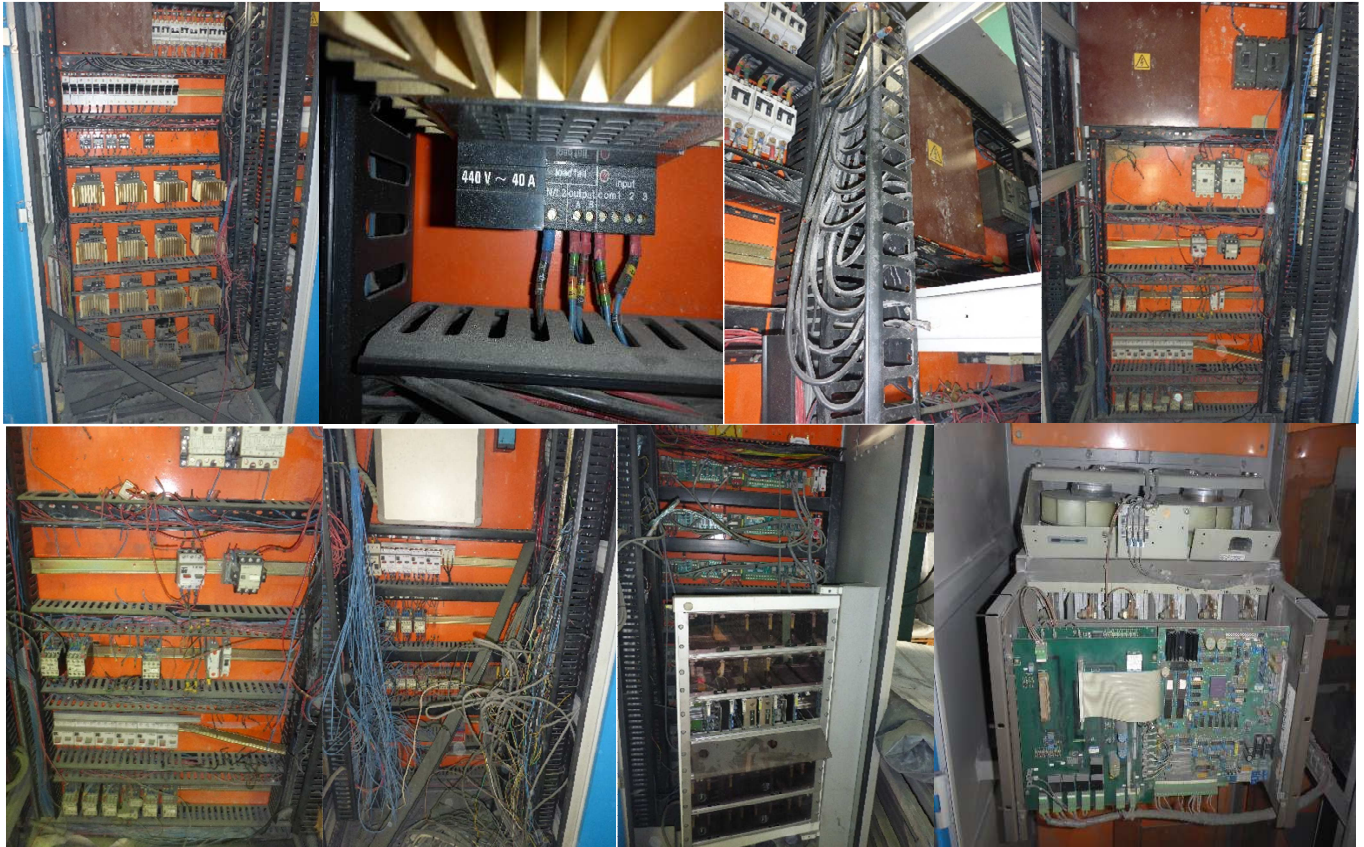
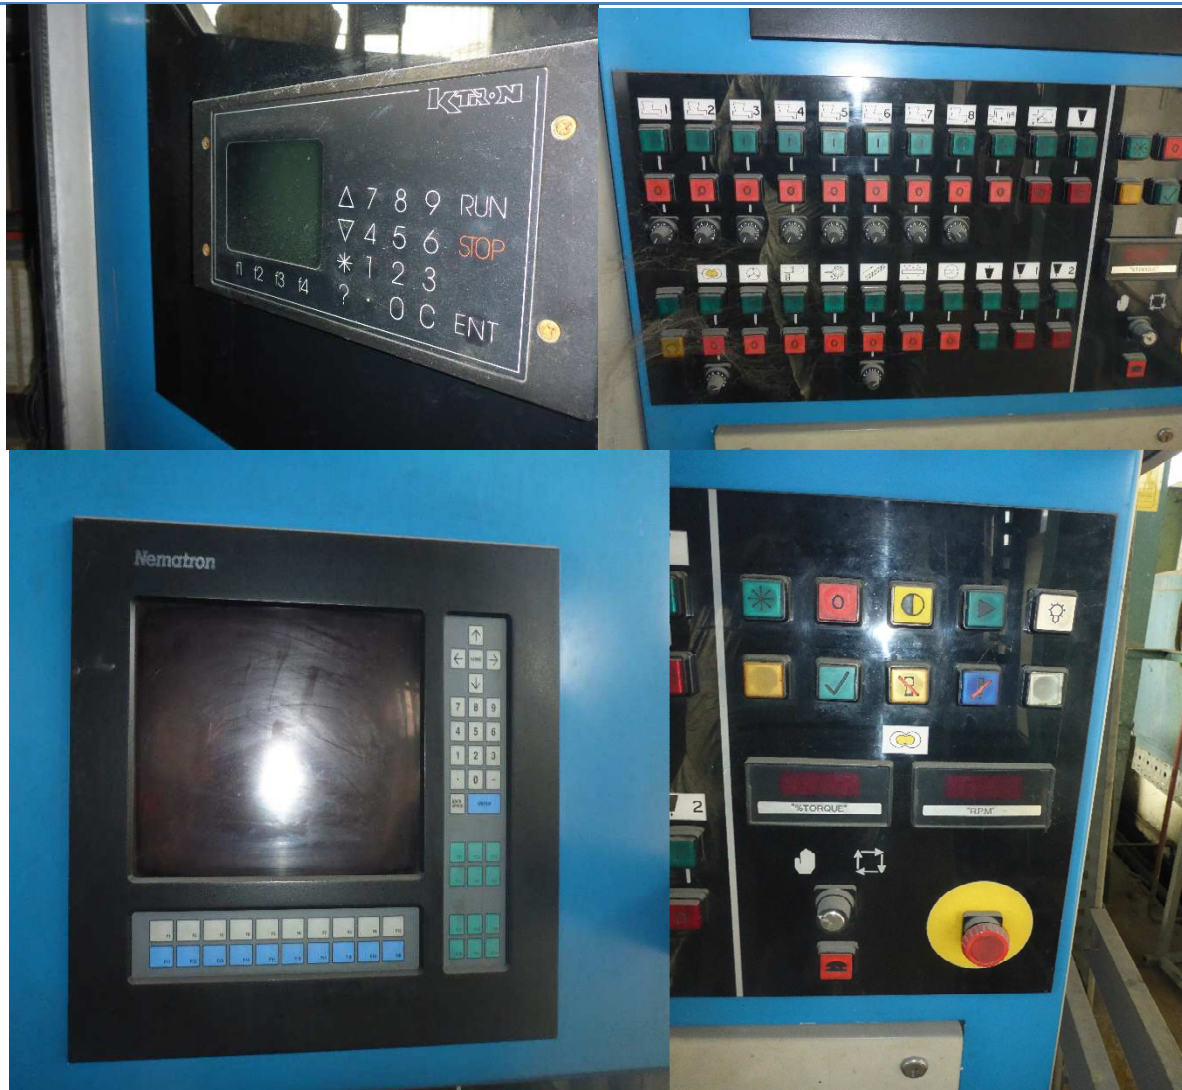
The extruder electrics/electronics have been badly vandalized and as far as I can see very little can be salvaged and a new panel would be needed in order to run the extruder and feeders.

The original panel controlled 8 feeders and all ancillary equipment and ran on Siemens S5 see below photos.

The basic requirements would be for a panel and wiring to control the extruder, main feeder, side feeders, and pelletizer. The customer would need to advise of any additional requirements.
